A STUDY ON THE WIND RESISTING CAPACITY OF TRADITIONAL ROOFING SYSTEM

Tshering Dema¹, Tshering Pema Dekar², Yeshi Dorji³, Tshewang Nidup⁴

Research and Publication Board, College of Science and Technology.

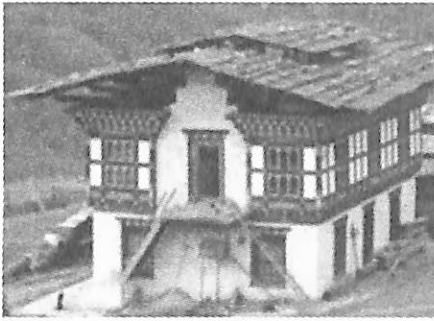
Fig.1 Transition from Shingles to CGI Sheeting

With the arrival of the modern construction materials, the traditional wooden shingles are gradually replaced with light corrugated galvanized iron (CGI) sheets and other similar materials. These material are considered to be more durable and convenient to work with requiring minimal maintenance.

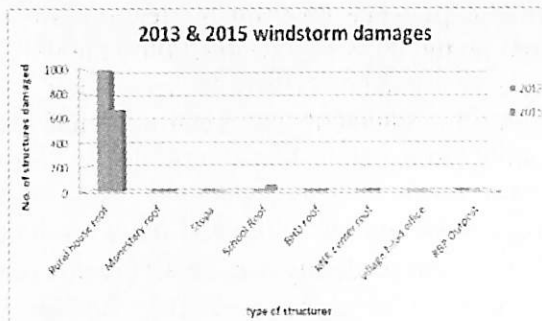
Fig.3 Type of structures affected by the windstorm(DDM)

According to a damage assessment report, 674 rural home roofs were damaged out of 748 total damaged structures (90.1%) during the year 2015 alone.

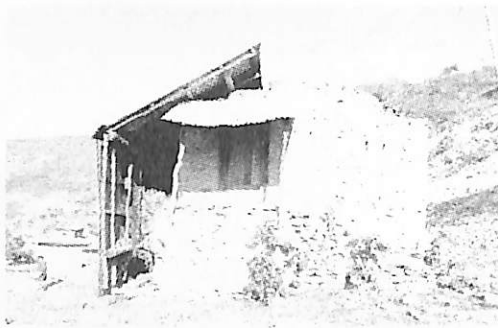
Fig.4 Wind damaged roofs(2011)
