# STUDY OF FLOOD EMBANKMENT DETERIORATION OF OMCHHU

Omchhu basin has a catchment area of about 22.52 km<sup>2</sup>. Omchhu runs across the heart of Phuentsholing town with tremendous discharges during monsoon. Past events of floods along Omchhu posed considerable losses and damages. The construction of embankment in 2001 have aided in reducing the damages, however the flood embankments along Amochhu and Omchhu still suffers greater deteriorations. The main causes for the deteriorations are intense rainfall, slope instability, high river bed incision rate, shorter span of river width and the quality of embankment protection works. A proper engineered, efficient and effective protection works are desired.

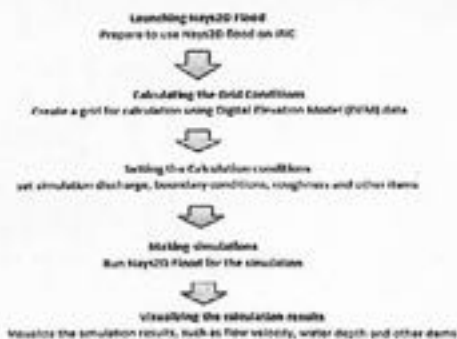
Figure 3: iRIC operation flow chart

For simulation of flood iRIC software application, particularly the Nays2D component is used in this project. The International River Interface Cooperative (iRIC) software application is an integrated software environment for river simulation. In the comprehensive iRIC software application, data can be compiled for river analysis solvers, rivers can be simulated and results can be visualized.

Data used for flood simulation were prepared from topographical map, satellite image (Google Earth), and Digital Elevation Model (DEM) using ArcGIS 10.1. The parameters used in this study have been selected based on the field verification as well as the review of related literatures.
